Raft slab failure in peatland in Co. Kildare

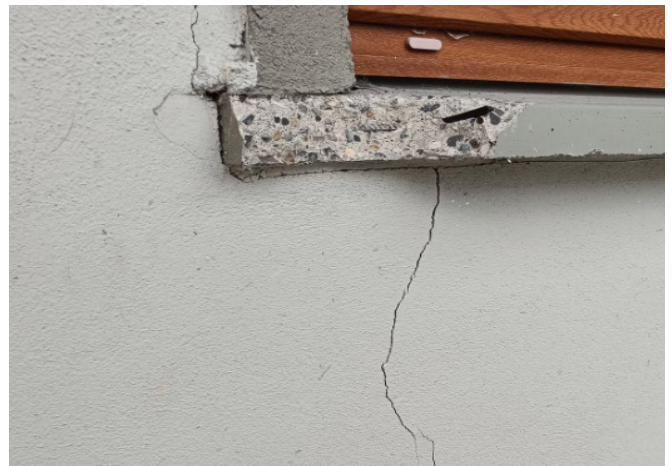
The property was built on a raft slab and the structure had cracks showing internally and externally. Additionally the internal floors were uneven with cracked floor tiles.

A drainage ditch adjacent to the side of the property where the cracking appeared was identified as the cause. It was a long-standing issue and the customer was looking for a cost-effective, viable solution that could be completed relatively quickly and at the right cost

We designed a treatment plan that had 11 injection points and treating to a depth of 2.1m below the base of the slab and into the fill.

A pre-design quantity of geopolymer was used per injection point and the ground improvement was verified by laser monitoring.
