# Subsiding internal slab at a detached two-storey property, Co. Kildare Ireland

## Background

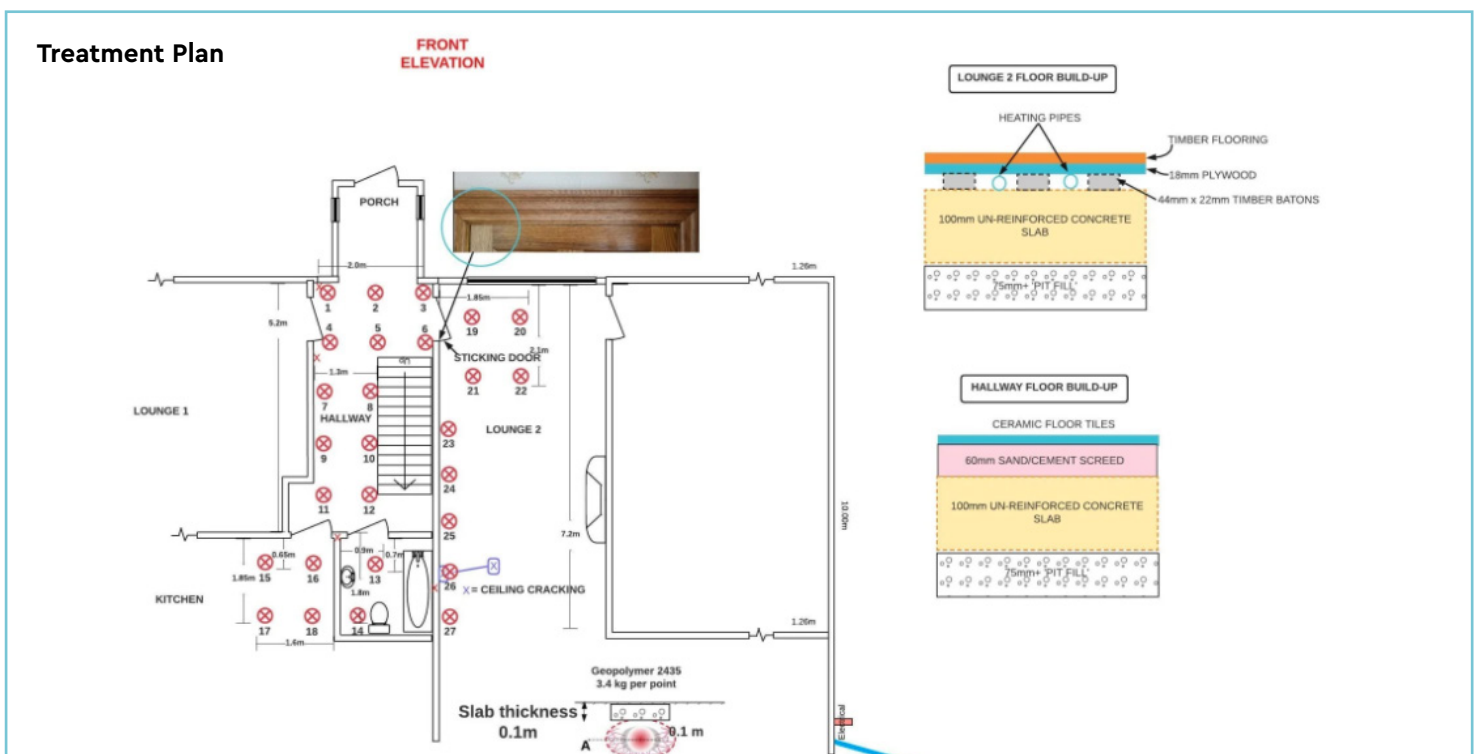
Due to a historic water leak, the customer had a dropped slab that spanned the kitchen, hallway, lounge, sitting room and bedroom on the ground floor. Consequently, the internal walls built off the slab were cracking as a result. It was a longstanding issue and the customer was looking for a cost-effective, viable solution that could be completed relatively quickly and at the right cost

Our design solution saw 27 injection points in a 1m grid pattern.

We drilled to a depth of 100mm below the base of the slab and into the fill material/void underneath.

Our injection tubes were placed into each point and a pre-determined amount of specialist geopolymer was installed at each injection point.
