Raft slab failure in peatland in Co. Kildare

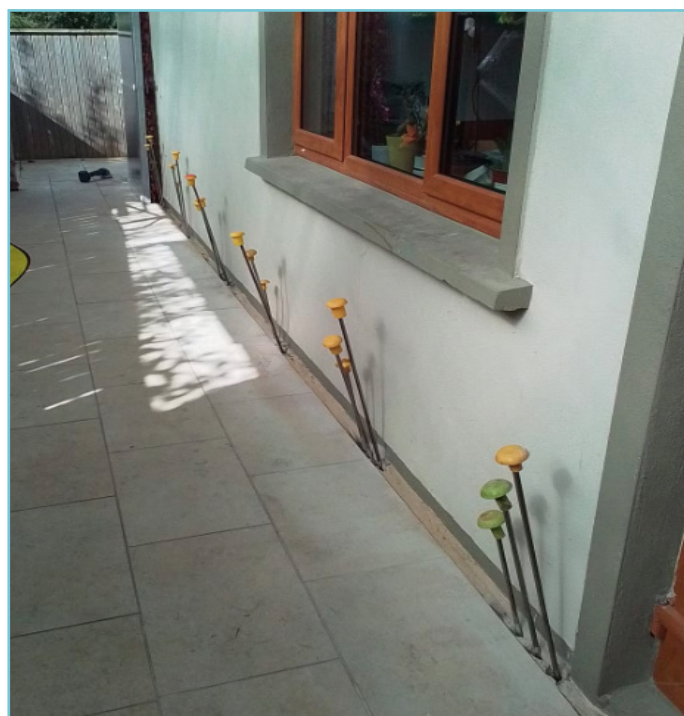
The property was built on a raft slab and the structure had cracks showing internally and externally. Additionally the internal floors were uneven with cracked floor tiles.

A drainage ditch adjacent to the side of the property where the cracking appeared was identified as the cause. It was a long-standing issue and the customer was looking for a cost-effective, viable solution that could be completed relatively quickly and at the right cost

Our solution was to use our minimally intrusive geopolymer injection method that we completed in one day with no excavation, spoil to remove from site or heavy plant on site (diggers, concrete trucks etc).

We designed a treatment plan that had 11 injection points and treating to a depth of 2.1m below the base of the slab and into the fill.

A pre-design quantity of geopolymer was used per injection point and the ground improvement was verified by laser monitoring.
